NASA  
Technical Memorandum 86939

## Experimental Study of Ceramic-Coated Tip Seals for Turbojet Engines

Prepared for the  
Ninth Annual Conference on Composites and Advanced Ceramic Materials  
sponsored by the American Ceramic Society  
Cocoa Beach, Florida, January 20-24, 1985

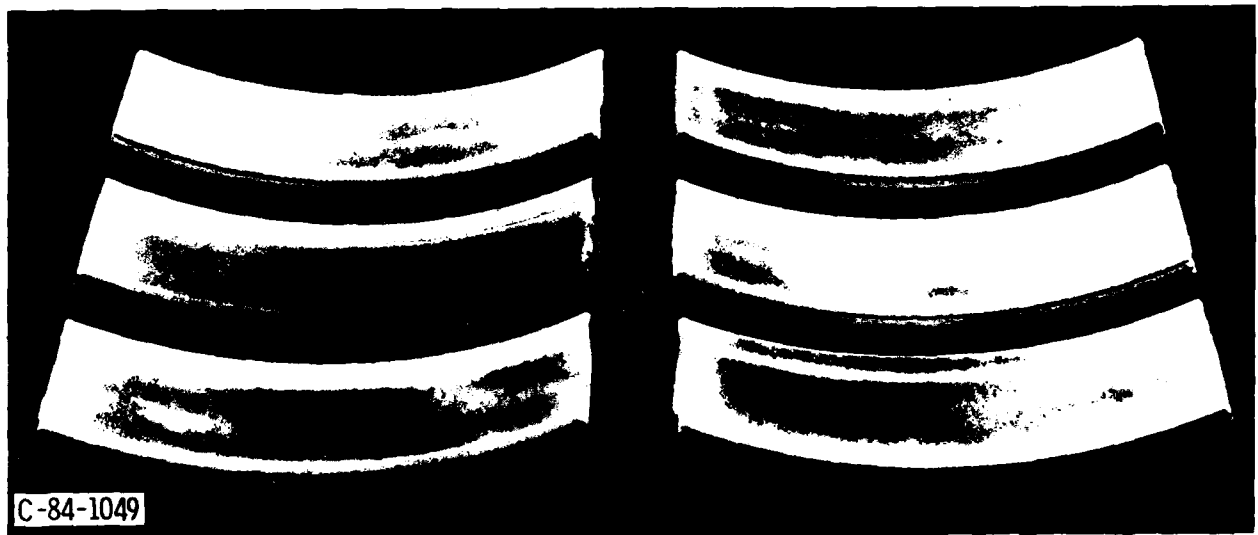
Figure 3. - Shroud segments after plasma spraying.

A cross section through a typical turbine tip shroud segment is illustrated schematically in figure 2, and the six shroud segments after application of the ceramic are shown in figure 3.

The shrouds before installation and after removal are shown in figures 3 and 9, respectively. The condition of the shrouds after removal is described in the analysis of the shroud seal material.

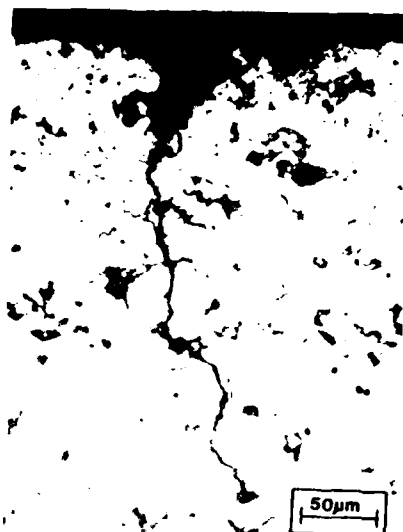
(b) Post-test microstructure; cross section A-A.

A pretest micrograph (fig. 17(a)) of a quality control specimen that was not run in the engine revealed some vertical cracking, which provides strain relief. The post-test ceramic coating microstructure (figs. 17(b) and (c)) revealed extensive segmentation, commonly called mudflat cracking, and some local areas of lateral cracking and large porosity. Apparently some densification of the ceramic occurred. However, caution must be exercised as microstructures are very dependent on metallographic polishing methods.
